1394 Link Layer Controller chip (TSB12C01A) Errata:

Last Changed on 07/06/96 - bsh, rgg

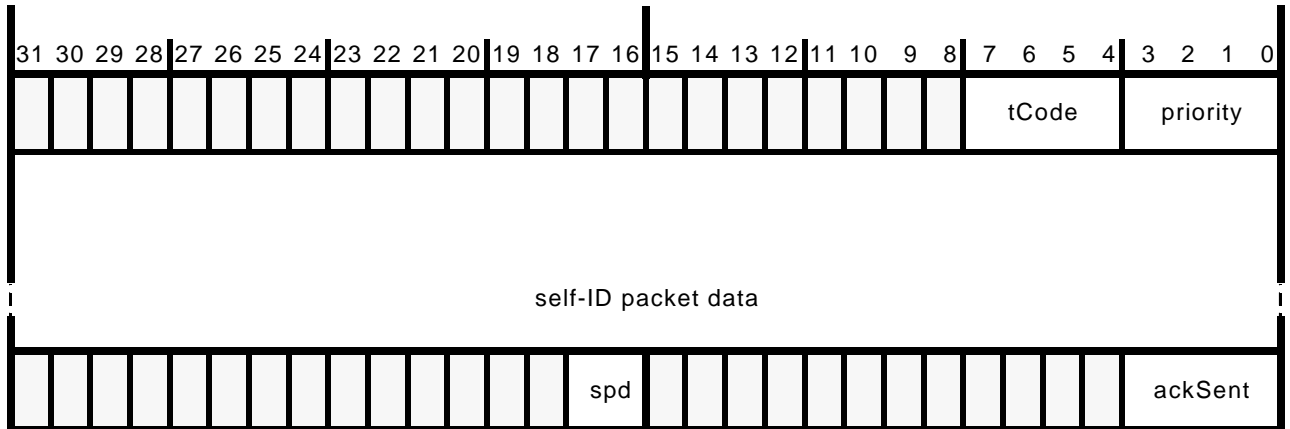
Figure 4-10. Receive Self-ID Format

1. Page 4-8 (Section 4.7 Receive Self-ID) should be replaced with the following page.

The format of the receive self-ID packet is shown in Figure 4-10. The first quadlet is the packet header with the special tCode of Eh. The quadlets following are a concatenation of all the received self-ID packets, followed by the final packet status quadlet.
