January 26, 1955

No. 15

CUSTOMER ENGINEERING

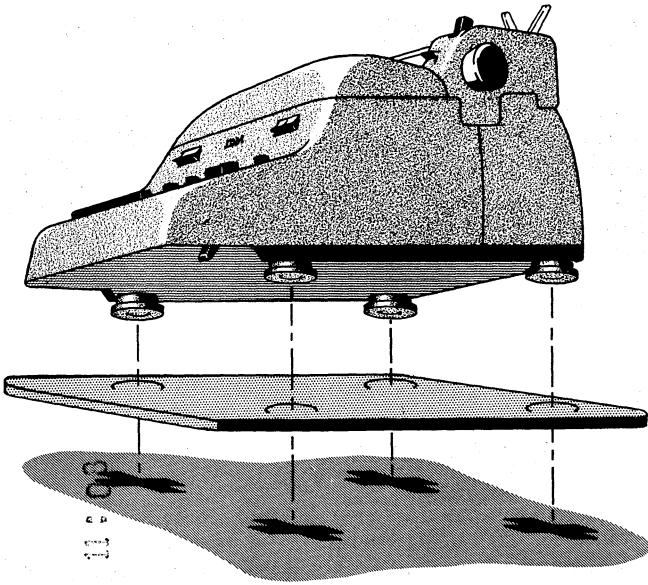
TYPEWRITER MOUNTING

It is not always possible to mount an ET to a desk, particularly loaned machines, demonstrators, and typewriters which are moved frequently. A simple method of securing typewriters in these categories is to form crosses using pieces of friction tape and stick them on the desk (under the typewriter pad) directly below each base foot.

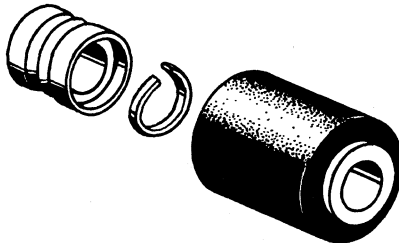
BAIL ROLL TENSION

The bushing of the bail roll assembly, part #1000382, is manufactured in two parts, therefore, the tension spring may be easily removed and formed to increase its tension. Use a small screw driver to remove one half of the two-section bushing for access to the tension spring.

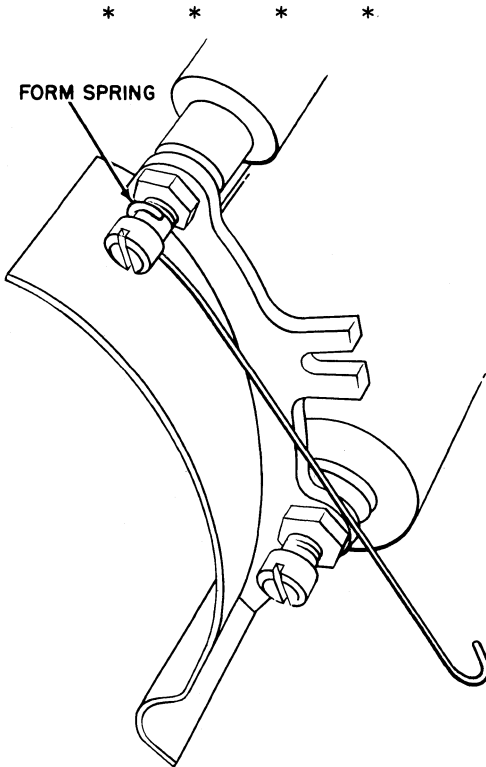
PAPER DEFLECTOR RETAINING SPRING

For easier, quicker removal and replacement of the paper deflector on Lift Platen typewriters, form one end of the retaining spring to be permanently hooked over the front feed roll adjusting screw. The springs will slide into place much easier and can be hooked over the rear screws without difficulty.

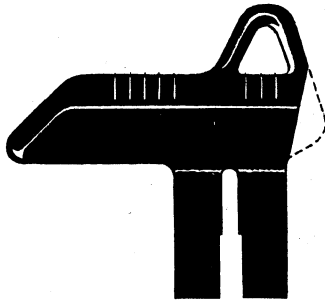
To overcome stubborn underprinting conditions, it may be found necessary to install the stainless steel underprinting shield, part #1109834, on typewriters equipped with the newly designed card holders. Due to added material of the card holders, it will be necessary to remove a portion of the LH and RH card holders as illustrated.
